DEPARTMENT OF TRANSPORT

RAILWAY ACCIDENT

Report on the Collision that occurred on 22nd October 1979 at Invergowrie

IN THE
SCOTTISH REGION
BRITISH RAILWAYS

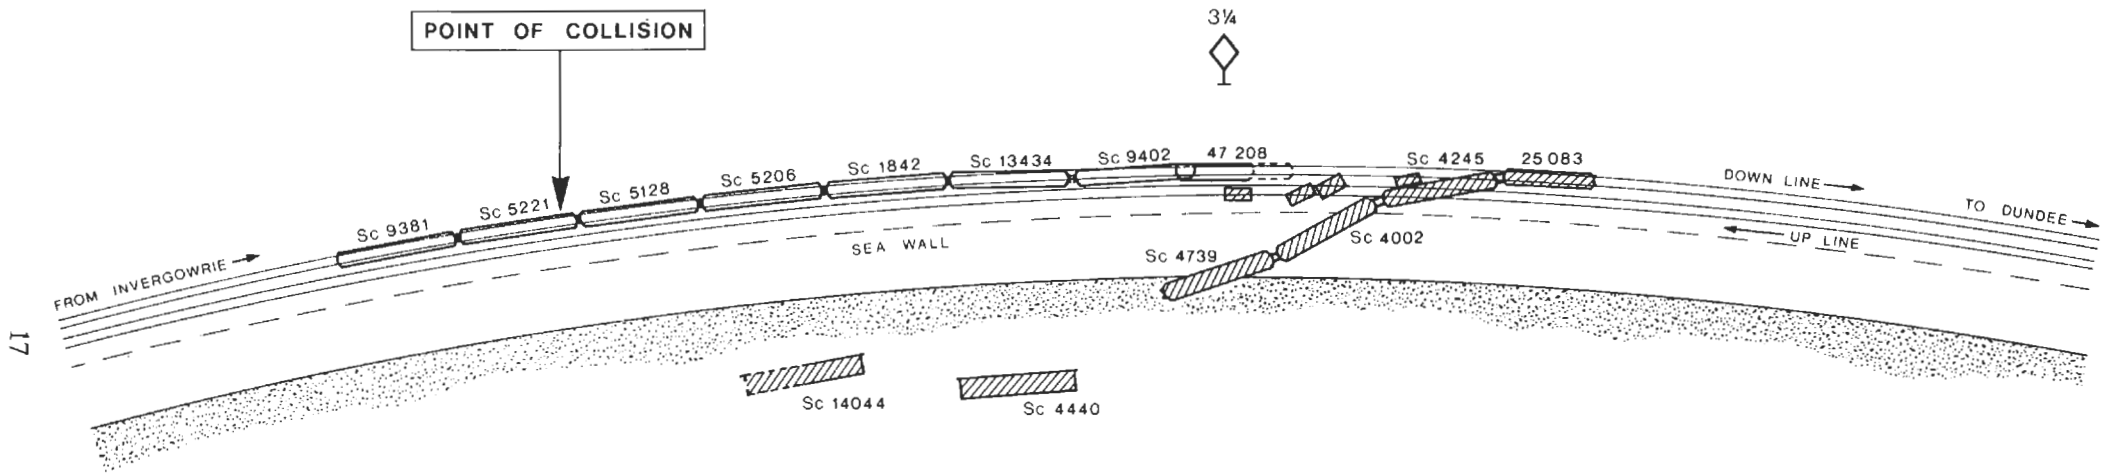
Figure 2

The 09.35 train passed through Invergowrie Station at about 70 mile/h, at which point the 08.44 train would have come into the driver's view, only a few hundred yards ahead. A last-second brake application reduced the train's speed to around 60 mile/h before it struck the train ahead. The force of the collision threw the two rearmost coaches of the 08.44 train across the sea wall and onto the muddy foreshore of the Tay estuary. Of the other three coaches in this train, the first was derailed and drawn towards the river and the second and third were projected onto the sea wall but remained coupled to the first coach. The locomotive was not derailed. The locomotive of the 09.35 train was very severely damaged and derailed all wheels. Its leading cab was totally crushed. The first coach was impacted into the rear of the locomotive and derailed all wheels, and the leading bogie of the second coach was also derailed. The remaining five coaches were not derailed and the complete train remained coupled together.

VEHICLE DISPOSITION AFTER COLLISION

(Vehicles and separated bogies of 0844 Glasgow to Dundee train shown shaded)

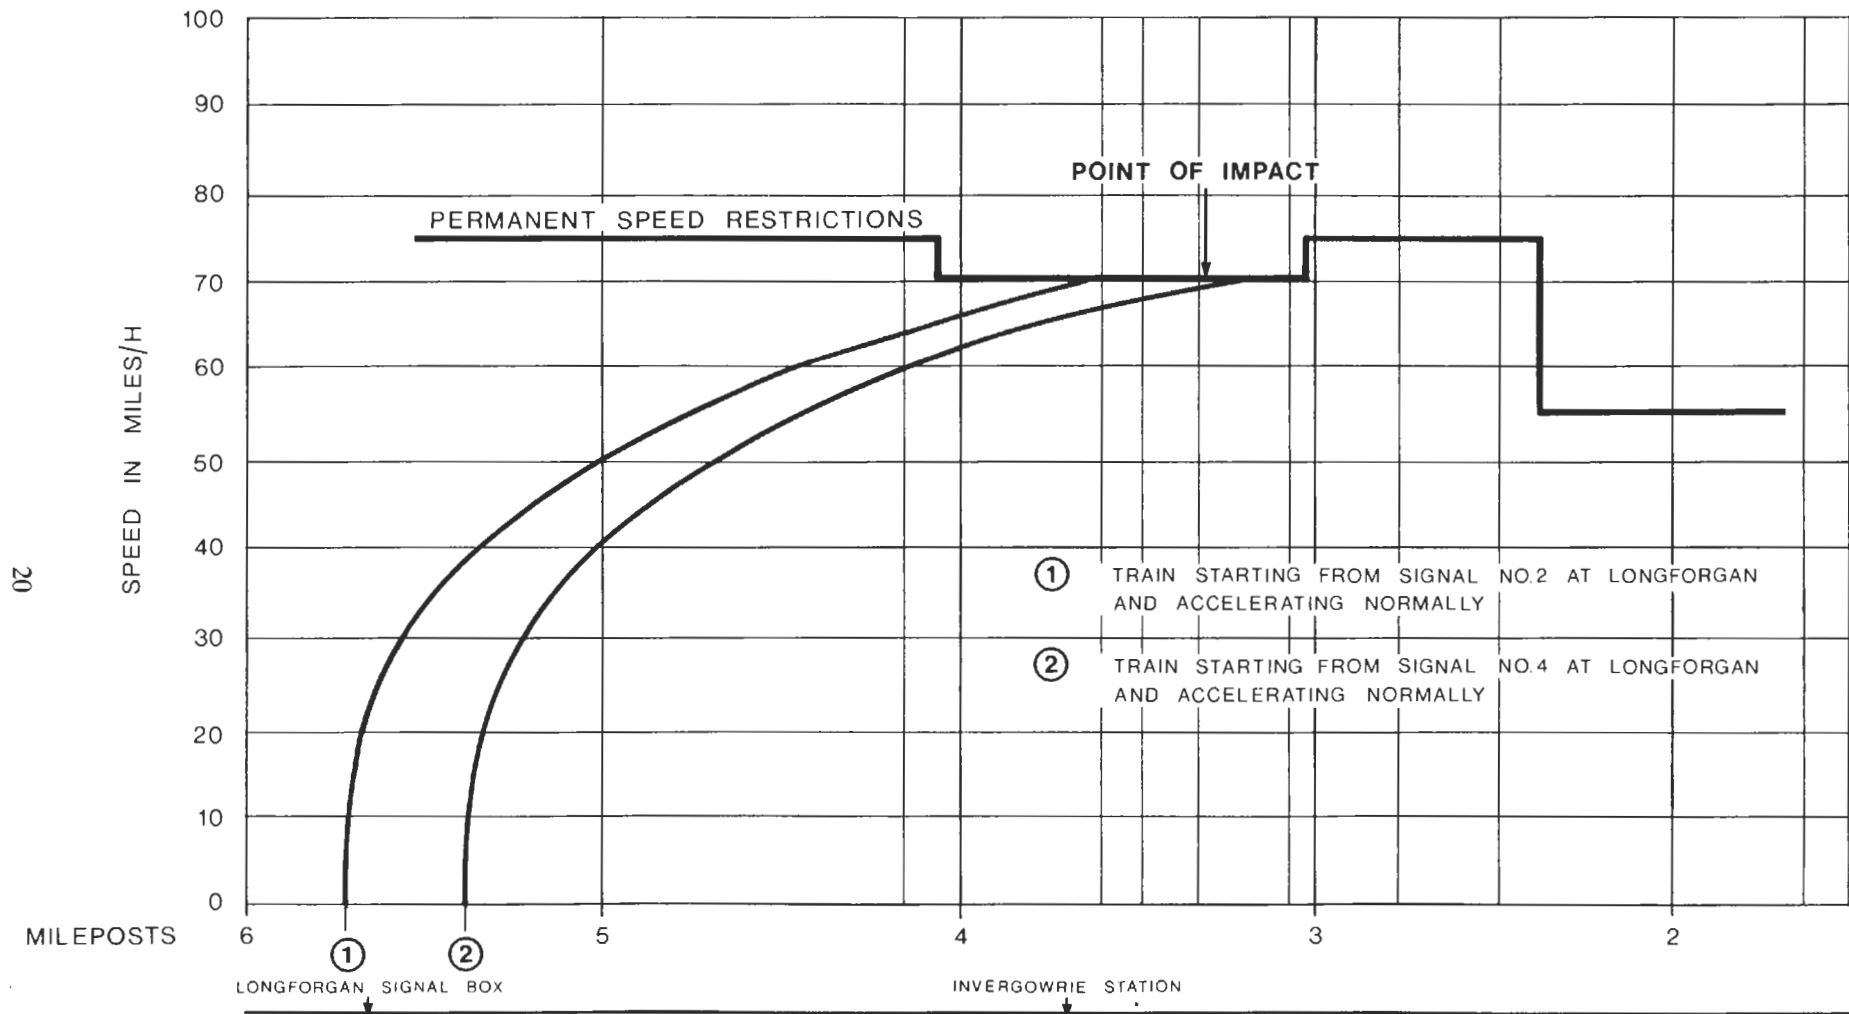
34. Mr. Passey then described tests and calculations made into sighting and braking distances at Invergowrie. He had determined that, if the 09.35 train had been approaching the Longforgan Down Section signal at 5 mile/h and had then accelerated normally, it would have achieved a speed of 70 mile/h by the time it reached Invergowrie. From the driver's cab, the point at which the stationary 08.44 train first came into view was 520 yards from the rear of the 08.44 train. Had a full brake application been made at the instant the other train came into view, the 09.35 would still have been travelling at over 40 mile/h when it collided with the train in front. However, Mr. Passey pointed out that owing to the curvature of the line it is highly probable that Driver Duncan would have assumed that the train ahead was on the Up line and that he would have travelled nearly half the distance of 520 yards before realising that the train was in fact on the Down line. An emergency brake application made from this point would have reduced the speed to between 55 and 65 mile/h. Such a speed would accord with the damage done in the collision, and the timing of the brake application would agree with Guard McRitchie's evidence. The results of these tests and calculations are shown in Figures 6 and 7 at the back of the report.

ACCELERATION CURVES FOR CLASS 47 LOCOMOTIVE HAULING 7 COACHES

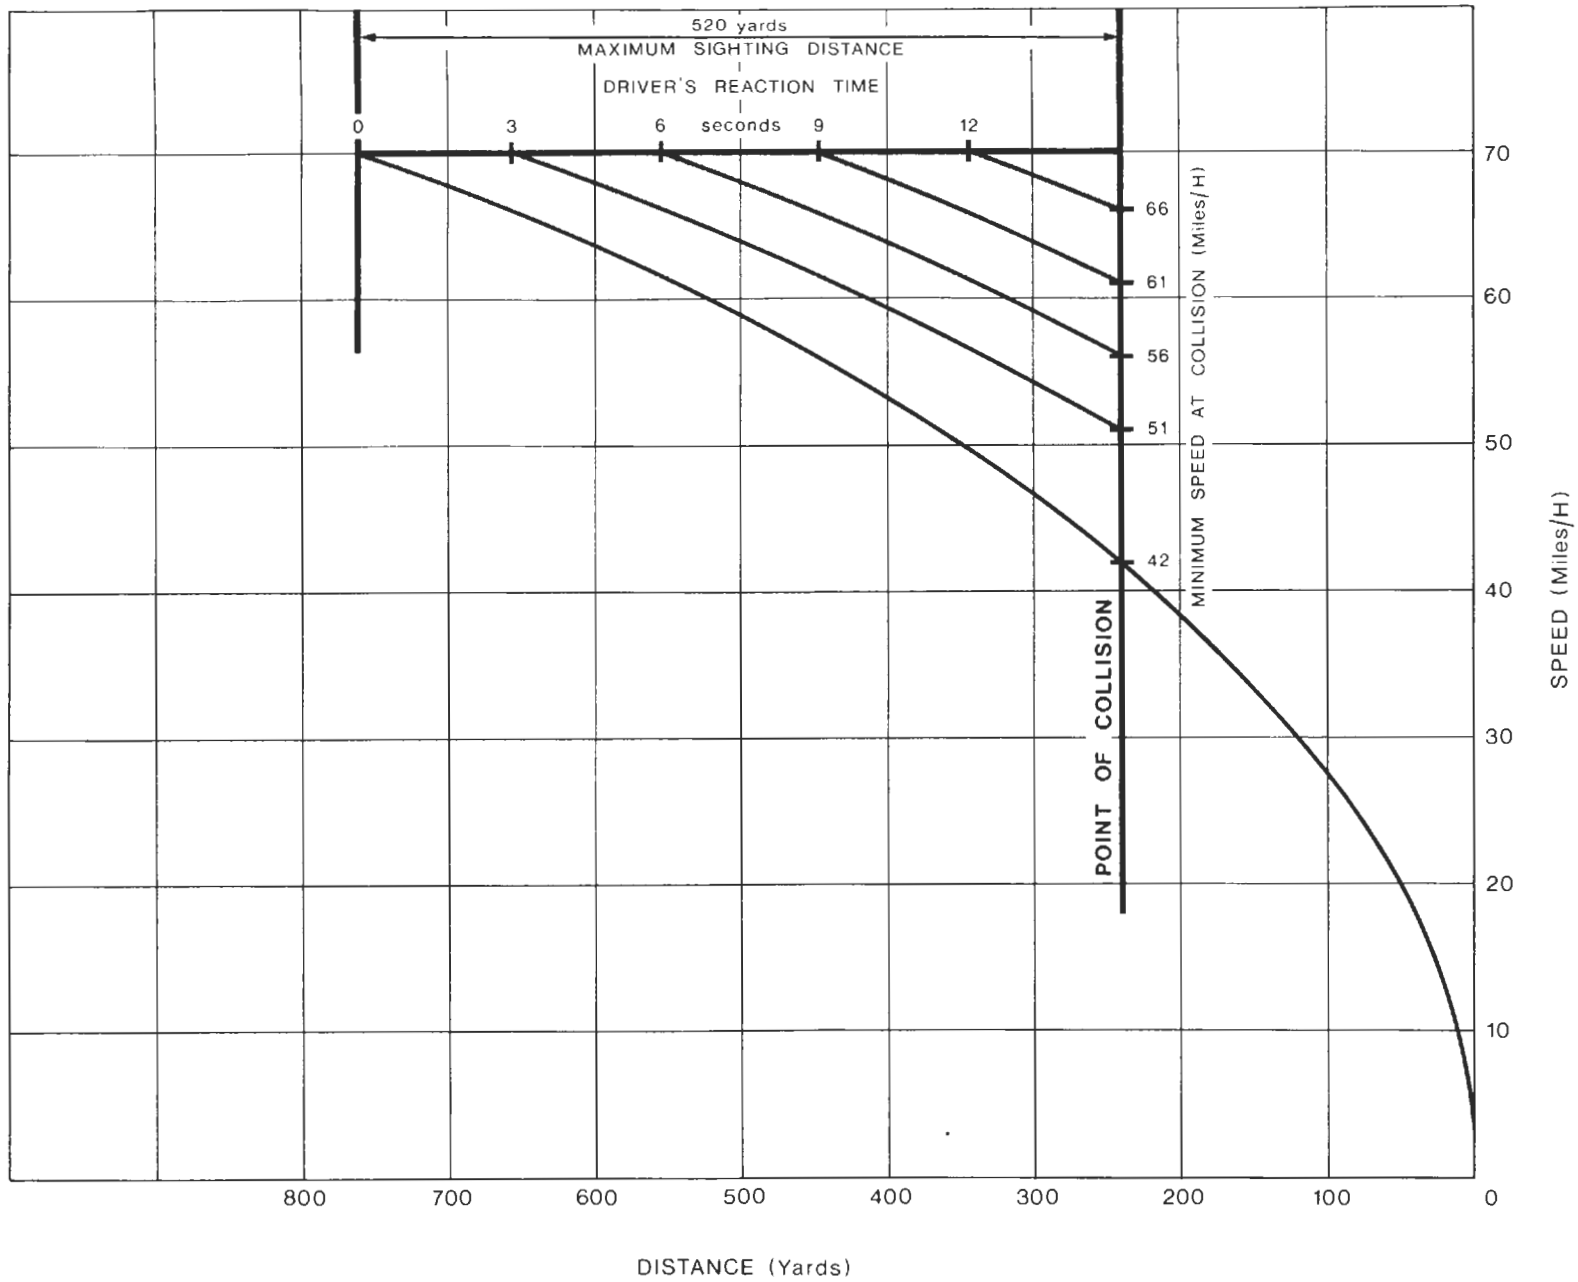
Figure 7

35. Finally, Mr. Passey described the tests that had been carried out on the brakes of the locomotive and train forming the 09.35 express. These showed that the brakes would have been in proper working order before the accident and that the braking performance would have been as designed.

EMERGENCY BRAKING CURVES (LEVEL GRADIENT) FOR 0935 GLASGOW/ABERDEEN TRAIN
COMPRISING CLASS 47 LOCOMOTIVE AND 7 COACHES

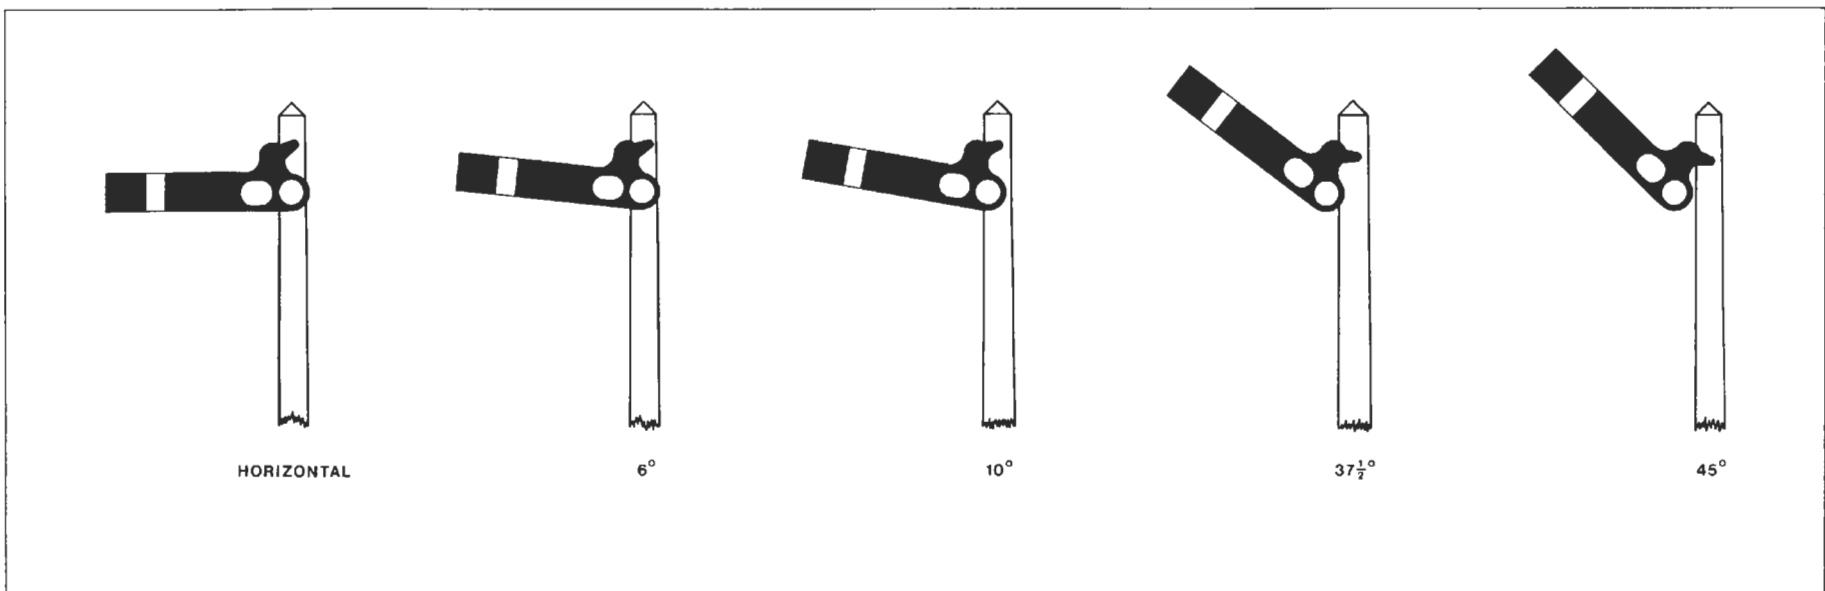
Figure 8

36. During the course of the Inquiry, I viewed the Longforgan Down Section signal, which had been set at 6 degrees above the horizontal, from the signal box, from the level crossing, and from various points on the roads around Longforgan, and also from the footplate of a class 47 locomotive which followed as far as possible the movements of the 09.35 train on the day of the accident. I was struck by the apparent differences in inclination of the signal arm when viewed from different places. From the signal box, the arm was visible against a background of dark trees which sloped upwards to the left and this may have helped to disguise the inclination of the signal, which it was almost impossible to detect. The inclination was more readily visible from the level crossing, with the arm silhouetted against the sky. From the footplate, the arm looked horizontal when seen from opposite the Home signal or opposite the signal box. However, when closely approaching the Section signal, it became quite apparent that the arm was not horizontal, although the apparent inclination was certainly not such as to constitute a proper clear signal. An indication of what a signal arm looks like at various angles of inclination is given on the drawing at the back of the report (Figure 8).

37. The direct cause of the accident was the passing of the Longforgan Down Section signal at Danger by the 09.35 Glasgow to Aberdeen express. The evidence suggests strongly that at the material time the semaphore arm of this upper quadrant signal was raised above the horizontal by at least 6 degrees but by not more than 10 degrees; in such a position it should have been taken to be an imperfectly exhibited signal and thus treated as at Danger, but for some reason the train driver passed the signal and continued into the occupied section.
